The Chronicles

The Subsea Solutions Alliance

August, 2012

Monthly Summary of Major Projects Performed by the Subsea Solutions Alliance

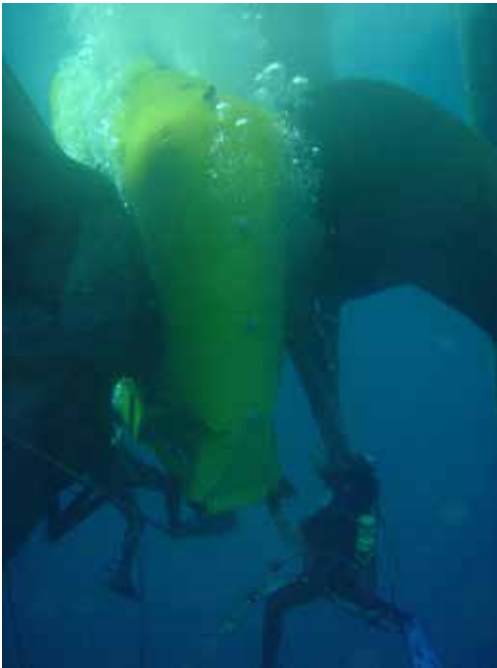
Azipods are fitted with very specialized sealing systems since a failure of this critical component will cause considerable damage to the propulsion unit. However, these critical seals are also susceptible to the same modes of failure that affect conventional propulsion shaft systems. With this being the case, the **Subsea Solutions Alliance** has created specific flexible hyperbaric cofferdams to support these repairs. By staging these systems in strategic locations throughout the world the **Subsea Solutions Alliance** is able to support repairs quickly when the need arises.

While both vessels operated cruises in and out of Bermuda, both vessels could not maintain the volume of seawater passing by the shaft seals. With both having a favorable itinerary and sufficient periods of time in Bermuda, it was decided to execute the seal replacements at this location. Each vessel was fitted with multiple Azipods and two Azipods per vessel required shaft seal renewal. Equipment and personnel was staged to Bermuda over sequential voyages in order to maintain the vessel in service and avoid any delays or changes to the cruise itineraries. Since Azipods are designed with enhanced rope guards and fairing plates over the seal assemblies, preparations for the repair were done in advance of the actual seal exchange. Utilizing separate Flexible Hyperbaric cofferdams for each seal assembly, two separate teams of diver / technicians from the **Subsea Solutions Alliance** were utilized on each vessel during each intervention. Each team consisted of two shifts of OEM trained diver / technicians that worked around the clock

The proven systematic approach developed and implemented by the **Subsea Solutions Alliance** was employed on both vessels. This included the installation of the Transhab, a flexible hyperbaric cofferdam. With the Transhab installed the seal assemblies were disassembled and new sealing rings were bonded in a dry hyperbaric environment by OEM trained and certified Diver / technicians. Once new sealing rings were installed, the seal assemblies were fully assembled, tested and prepared for service. By being the exclusive underwater service agent for Blohm and Voss shaft seals, the **Subsea Solutions Alliance** is able to provide a fully backed and warranted permanent repair. Utilizing the same bonding

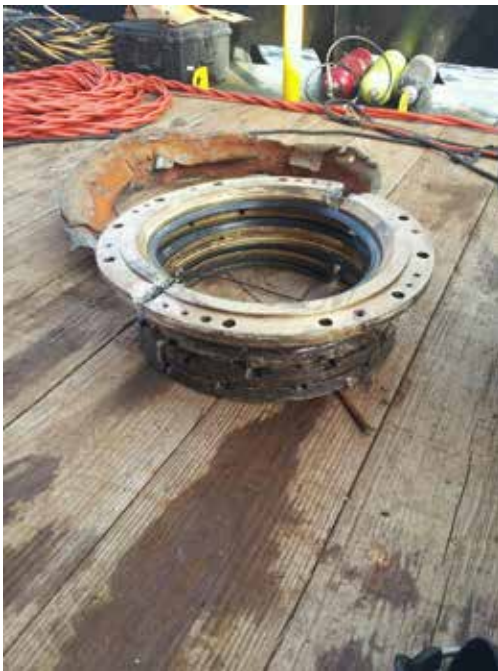
While sailing fully loaded down a river in Venezuela, the vessel's main engine suddenly stopped. A chain from a buoy was wrapped between the propeller blades and the rope guard causing severe damage to the rope guard, seal housing and seal assembly. The oil from the stern tube was immediately lost leaving the vessel completely disabled. The crew attempted to refill the stern tube with fresh oil but the oil was lost again to sea. In addition to the stern tube seal damage, the crew reported strong vibrations during the short operation of the main engine after the accident; thus indicating that the propeller was damaged. The actual extent of the damage would not be revealed until a detailed inspection was performed by qualified propeller technicians from the **Subsea Solutions Alliance**. With such severe damage occurring to the vessel, the port authorities immediately confined the vessel to its current location and would not allow the vessel to maneuver under its own power until repairs were performed. With the vessel being fully loaded and conditions on the river where the vessel was confined not suitable for an underwater repair, the owners of the vessel towed the vessel to Trinidad where the **Subsea Solutions Alliance**, the diving partner of the Original Equipment Manufacturer, had personnel and equipment in place. An inspection and eventual repair of the sealing system and propeller commenced.

The inspection revealed severe damage to the seal assembly, seal housing and seal liner. A complete seal renewal with a new liner was required. Considering the lead-time for a "split type" system for the existing seal assembly was over six (6) weeks, the client considered an alternative "face type" seal assembly from the same OEM. This "face type" seal system could be provided in less than 2 weeks; however it had never been installed underwater. After detailed discussions and planning meetings were completed with the client, OEM and the **Subsea Solutions Alliance**, the repair was initiated.

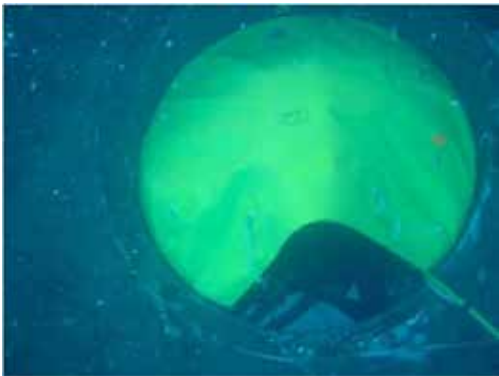
Operational Tunnel thrusters are necessary maneuvering tools when it comes to operations in the cruise business. With vessels entering and departing ports each and every day and some of these ports do not have tug support for a vessel's needs, severe penalties and costs could be incurred by the cruise operator if these essential pieces of equipment are not in service. Considering the focus on safety and reliability that exists in this market, operators are reluctant to take their assets out of service for repairs as this will require cancellations and skipping of ports. This is where the **Subsea Solutions Alliance** is called upon to make critical repairs.

Instead of taking the vessel out of service for a period of time and exchanging the affected tunnel thruster, a critical in-water repair was selected to put the system back into service. Developing a repair time line and repair procedure in accordance with the Original Equipment Manufacturers and Class requirements, the **Subsea Solutions Alliance** performed the critical exchange of the OD box together with the OEM in the Southeastern USA. As required by the client and regulatory bodies in the port, the OD Box was exchanged in a completely dry environment utilizing the **Subsea Solutions Alliance** flexible hyperbaric door

system. Cruise operators and port authorities where these vessels operate require the reporting of ANY risk of oil discharge to the sea; irrespective of how low the risk maybe. Considering this severe focus on the environment, a hyperbaric dry repair was selected.
